Causing a Black Tide of Oil – South Sudan's Polluting Pipeline

Konstanz, Germany, February 25, 2020,
Hoffnungszeichen | Sign of Hope e.V.

Key findings

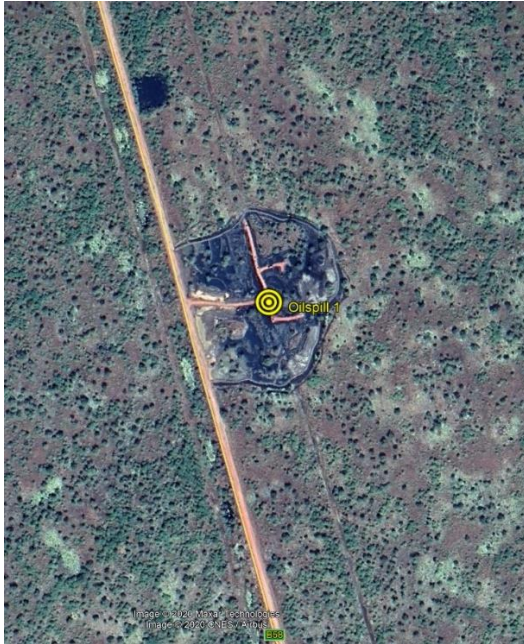
Figure 4 shows oil spill 1, upon which repair work has been carried out. High-resolution image dated November 1, 2019 (GoogleEarth).

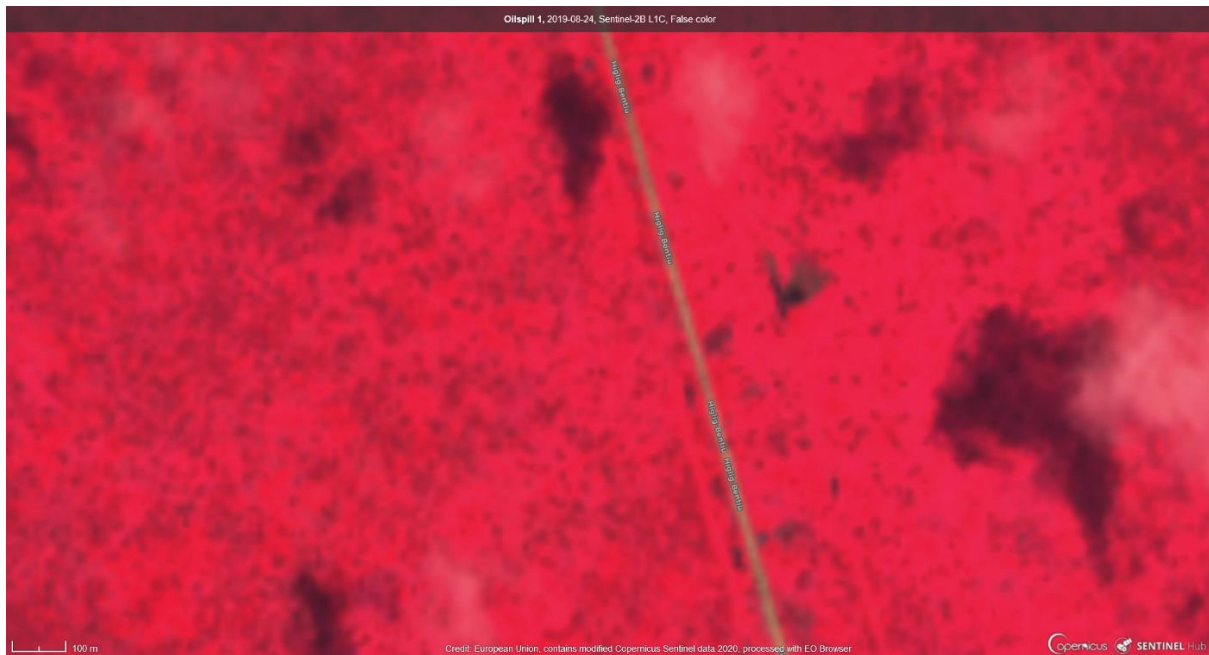
Figure 6: Image from August 24, 2019. It provides the initial indications of a possible oil spill. It is found to the right (to the east) of the road and somewhat above the middle of the image. It shows what might well be oil spreading along the pathway of the pipeline. Appearing to the northeast is a streak of an irregular shape. It starts spreading.

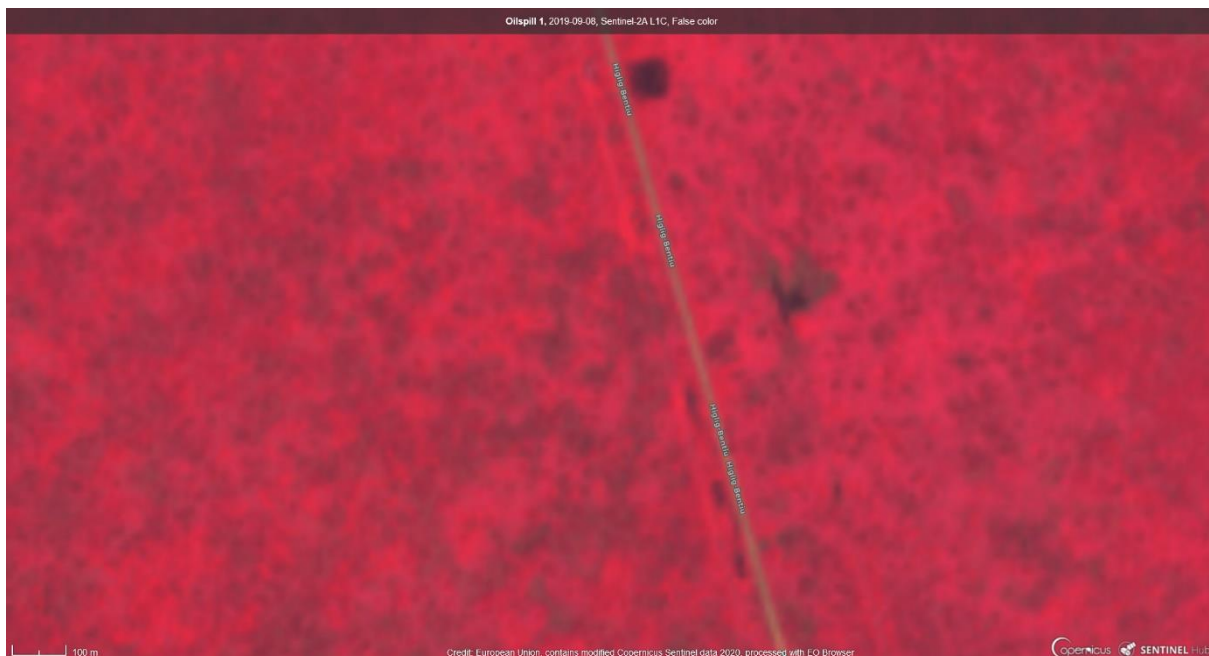
Figure 7: Image from September 8, 2019. The streak flaring towards the northeast continues to slightly grow.

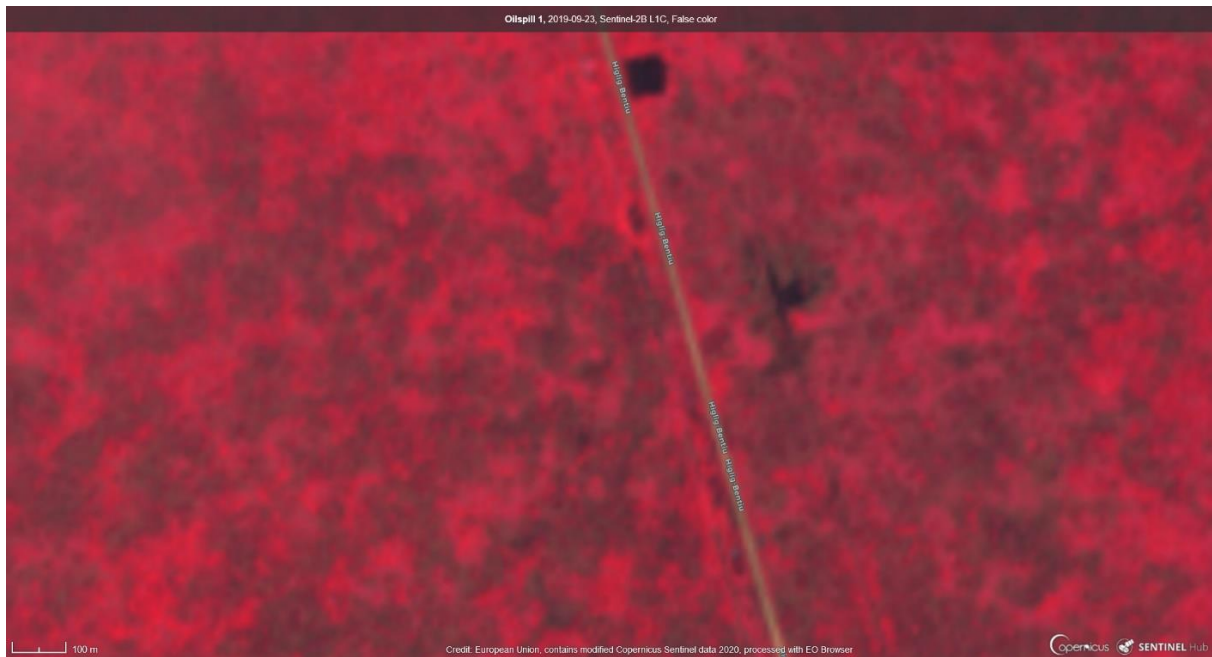
Figure 8: Image from September 23, 2019: The spot has spread southwards and along the surface of the pipeline's path.

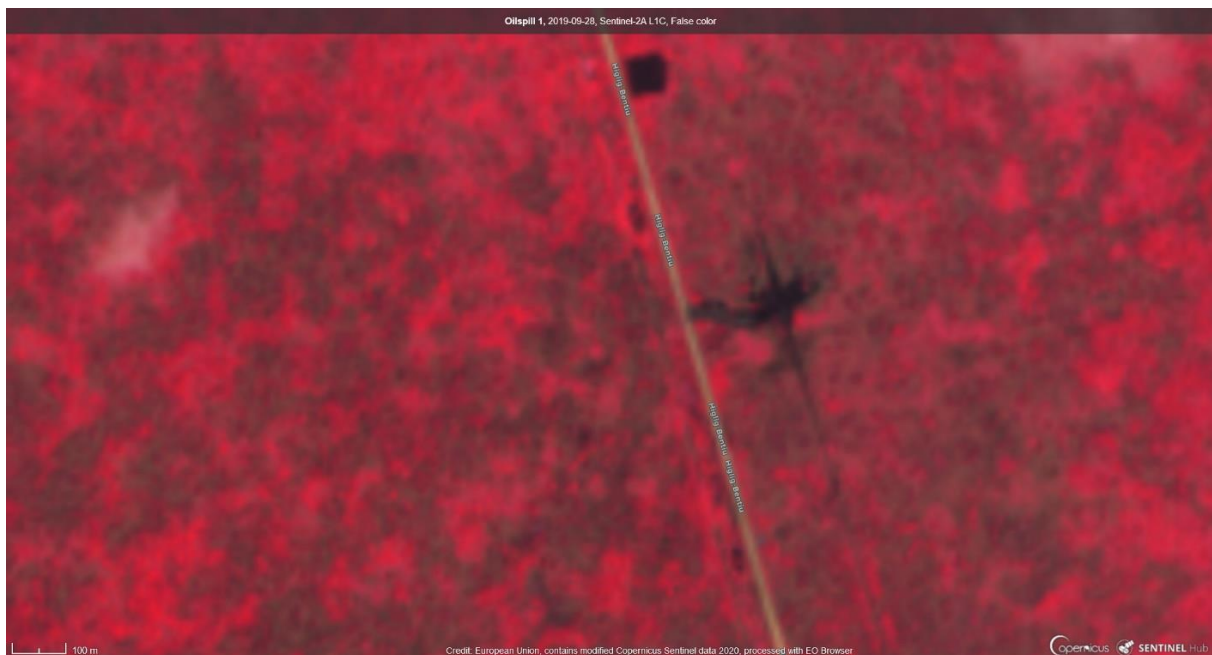
Figure 9: Image from September 28, 2019. It shows massive spreading in all directions. The expanse of the surface contaminated has reached the road. It was possibly at this point in time that the oil spill was discovered by passersby, who consequently and incorrectly assumed that the spill had begun on September 25th. An attempt to map the expanse of the

area contaminated yielded an estimate of some 10,000 m². The assumption that the layer thickness of oil amounts to a mere 20 centimeters and that it covers the entire expanse of contamination gives rise to the following calculation: some 12,500 barrels of oil – equivalent to some two million liters – have been already spilled.

In remarks made on October 2019, Awow Daniel Chuang, South Sudan's minister of petroleum and mining, stated the area contaminated came to 400 m² and the oil spilled due to the rupture came to 2,000 barrels (= 318,000 liters).¹² The satellites-generated images and the measurements and calculations based on the satellite imagery refute the plausibility of this view.

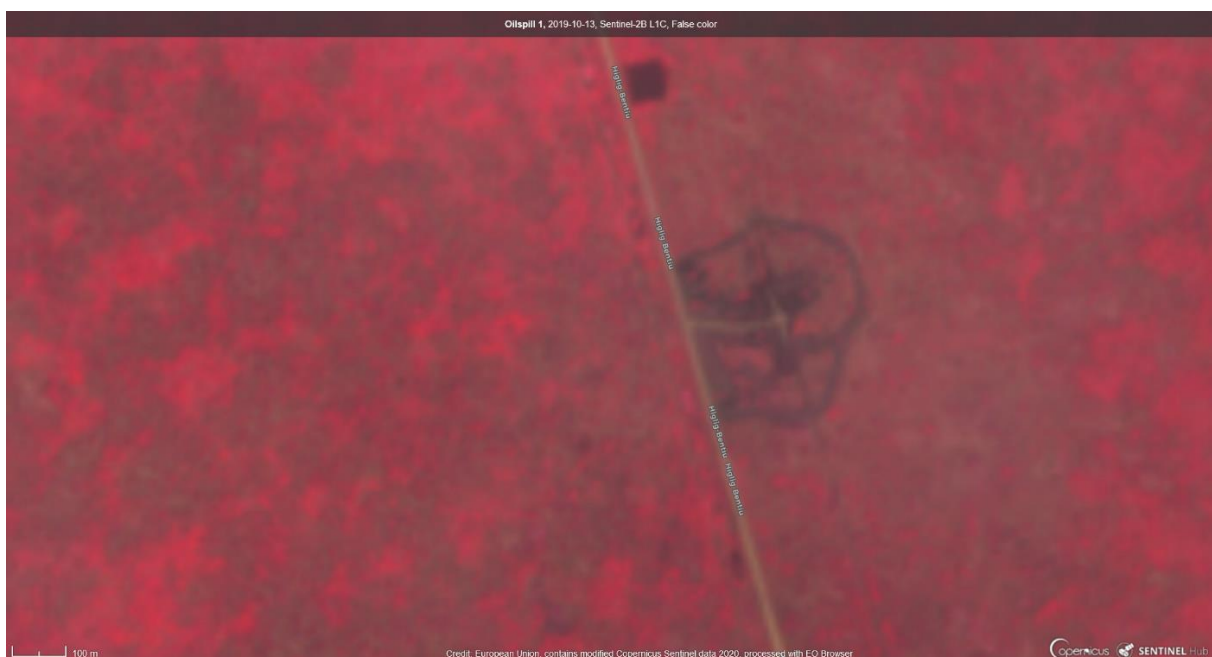
Figure 10: Image from October 13, 2019. The oil consortium is obviously busy repairing the pipeline. The first step is to have created a perimeter – made out of unidentified material – around the area affected. An access way has been laid from the road to the middle of the area. It can be used by heavy equipment.

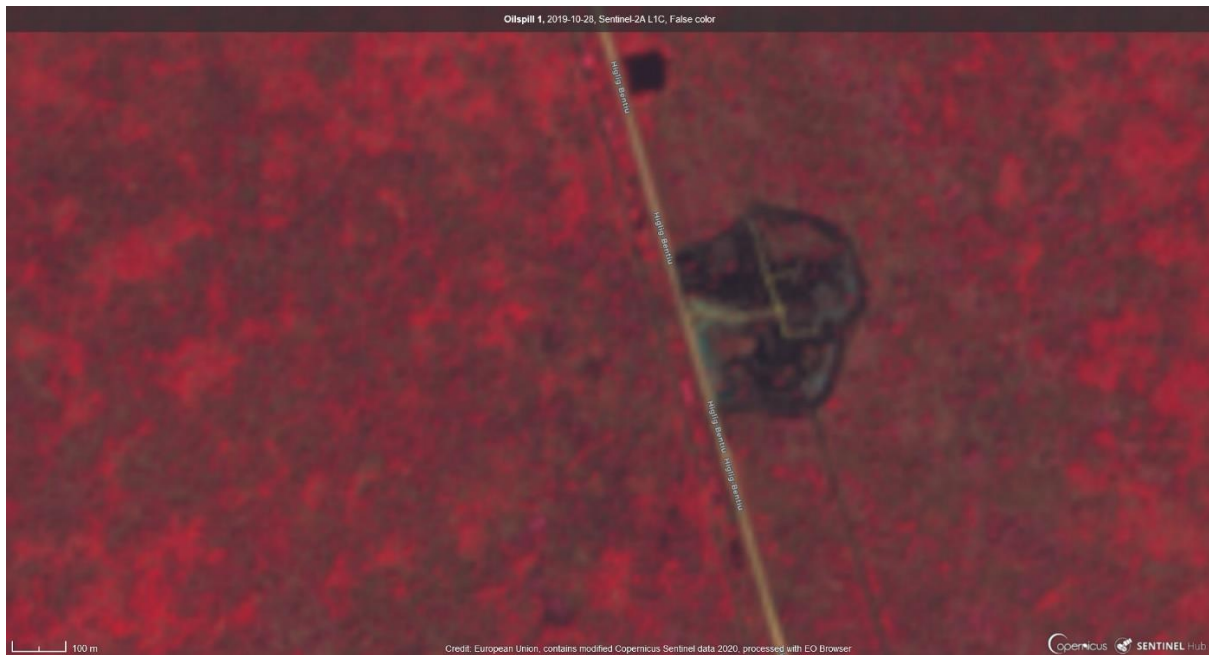
Figure 11: Image from October 28, 2019. This was the point of time of the conclusion of the changes made in structures and detectable via Sentinel-2 satellite images. The roads used by heavy equipment have been extended.

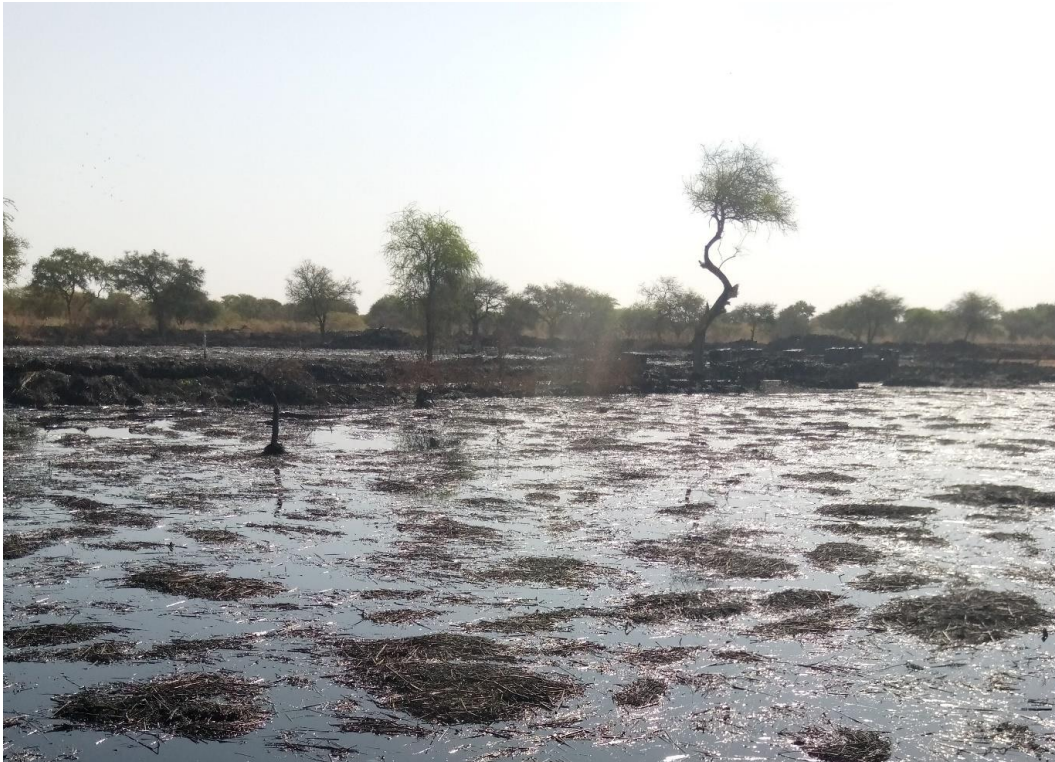
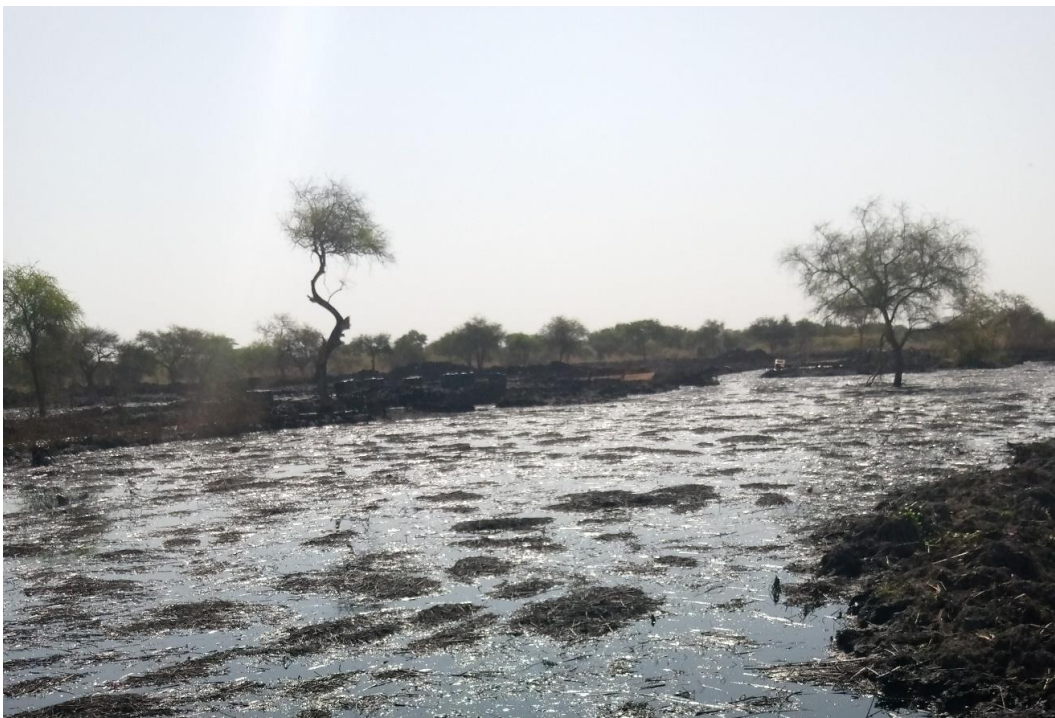
Figures 13 and 14: The area comprising oil spill 1 is large in size and is contaminated with oil. This is subsequent to the “remedial” measures performed by the oil consortium. What is obviously taking place: the oil spilled could not be completely disposed of by December 2019. Straw was apparently thrown on to the oil-saturated surface. This may have possibly been an attempt to bind the oil. Located to both the right and left of the S-shaped tree are at least six black containers. They have most probably been filled with oil wastes.

The on-site investigation of December 2019 clearly confirmed that the area that had been suspected to be the site of an oil spill and identified using satellites-generated images was in fact actually such. This pipeline rupture caused a large-sized expanse of oil contamination. A proper cleaning-up of the area affected has not been done until the date of the on-site-investigation.

Even if the pipeline has by now been repaired, the large-sized area of contamination has still to be cleansed of oil and its wastes, which in turn, have to be disposed of properly.

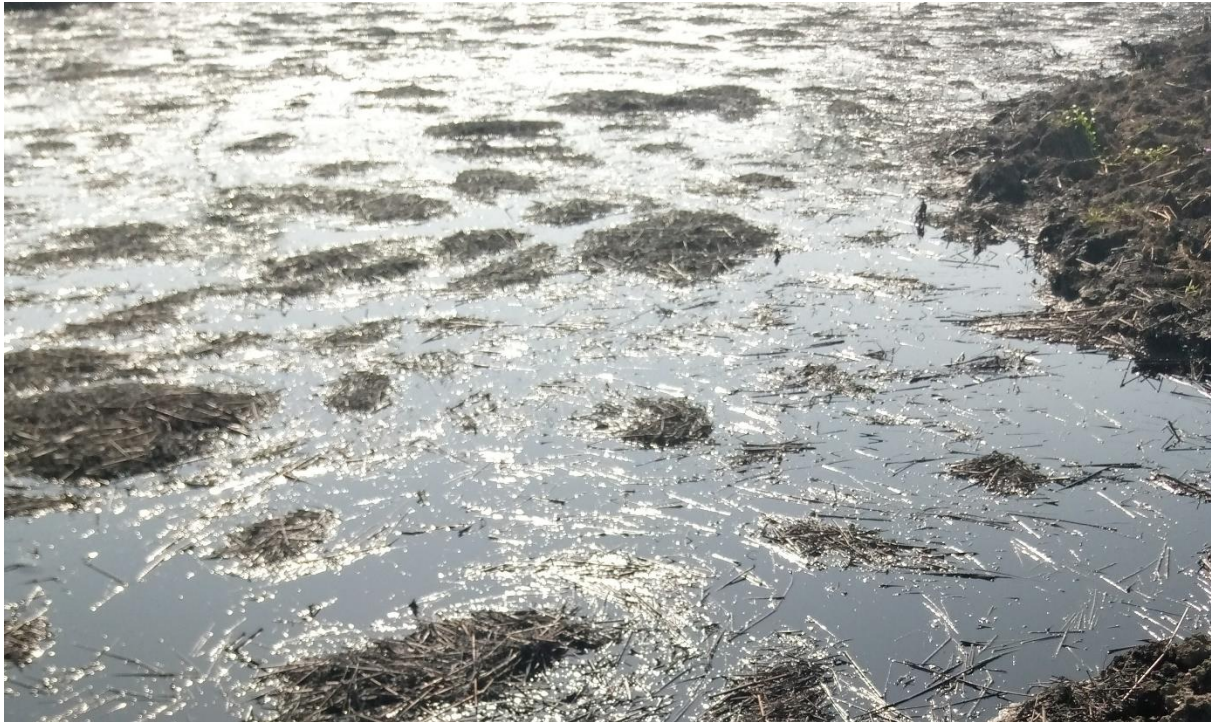
Figure 15: Detailed photograph of the banks of oil spill 1. Clearly visible are the oil and the straw brought in to deal with it.

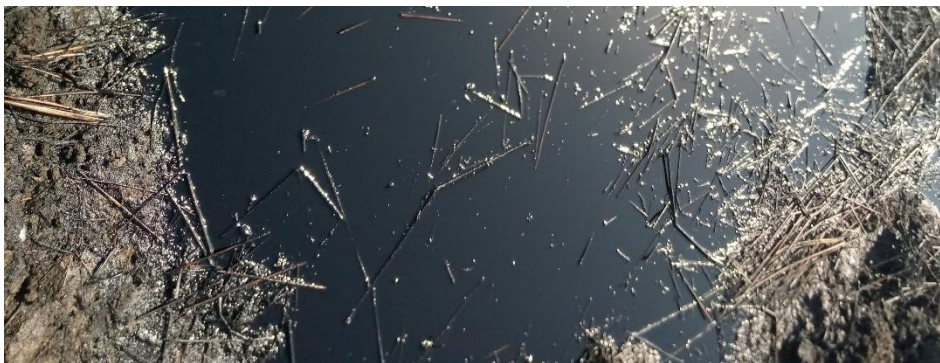
Figure 16: Detailed photograph of the banks of oil spill 1. Clearly visible are the oil and the straw brought in to deal with it.

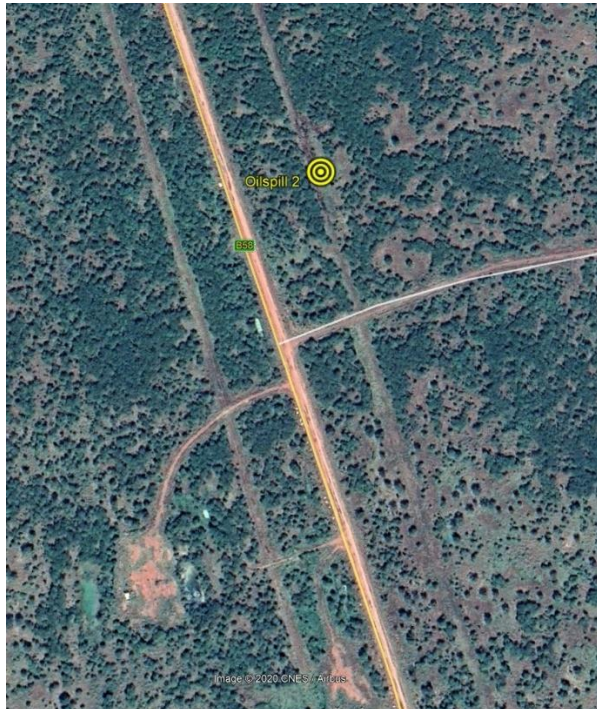
Figure 17 shows the location of oil spill 2 shortly after the suspected break of the pipeline. This high-resolution image was dated November 1, 2019 (GoogleEarth).

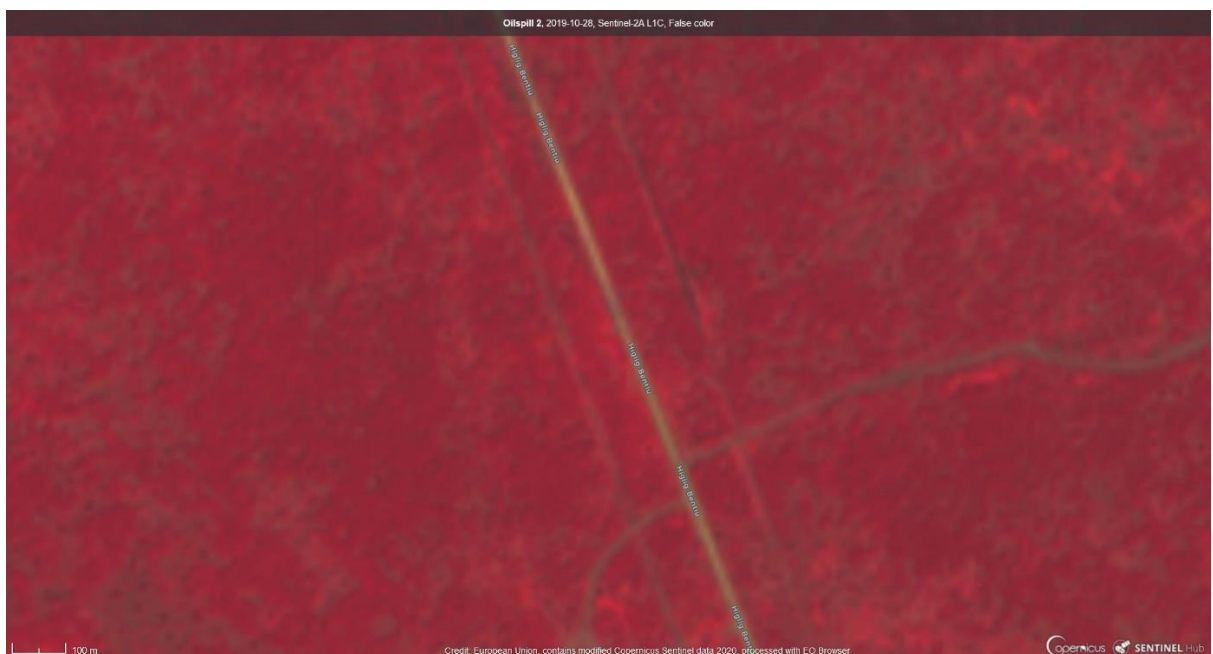
Figure 19: Image from October 28, 2019. The area of initial investigation is found to the right (to the east) of the road. The area is somewhat above the middle of the image. What the image shows: something that might be oil is spreading on the surface and along the course of the pipeline. A streak – small at the beginning – is spreading irregularly towards to the east.

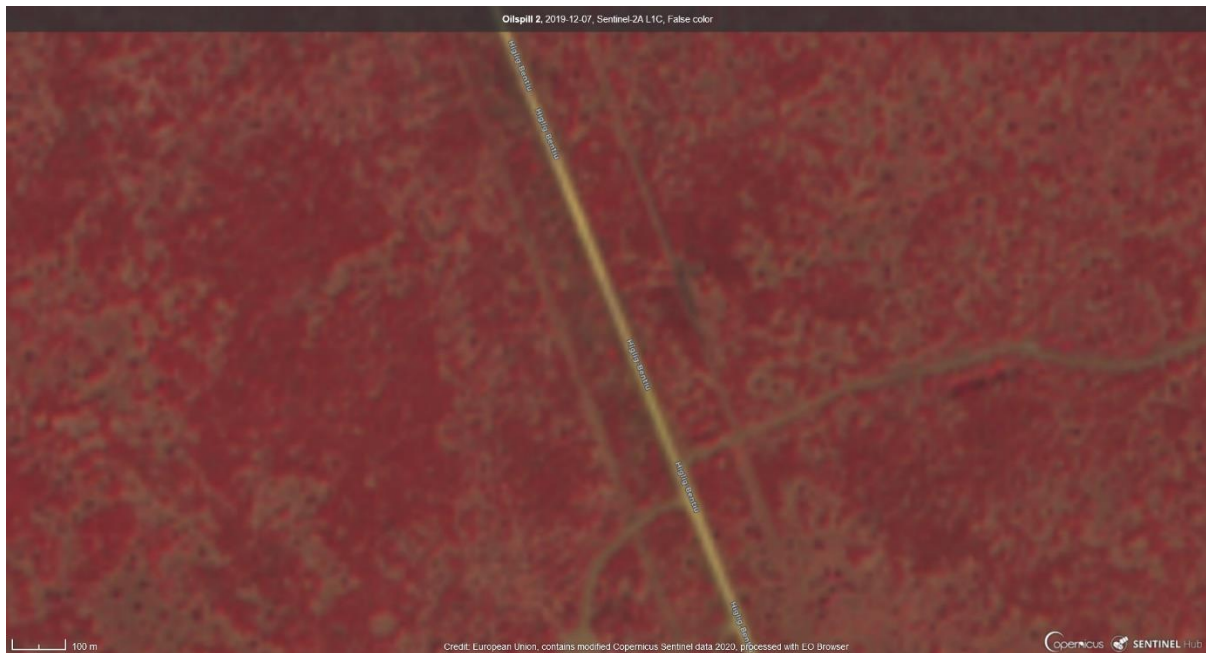
Figure 20: Image from December 7, 2019. It shows streaks spreading towards the northeast and southwest.

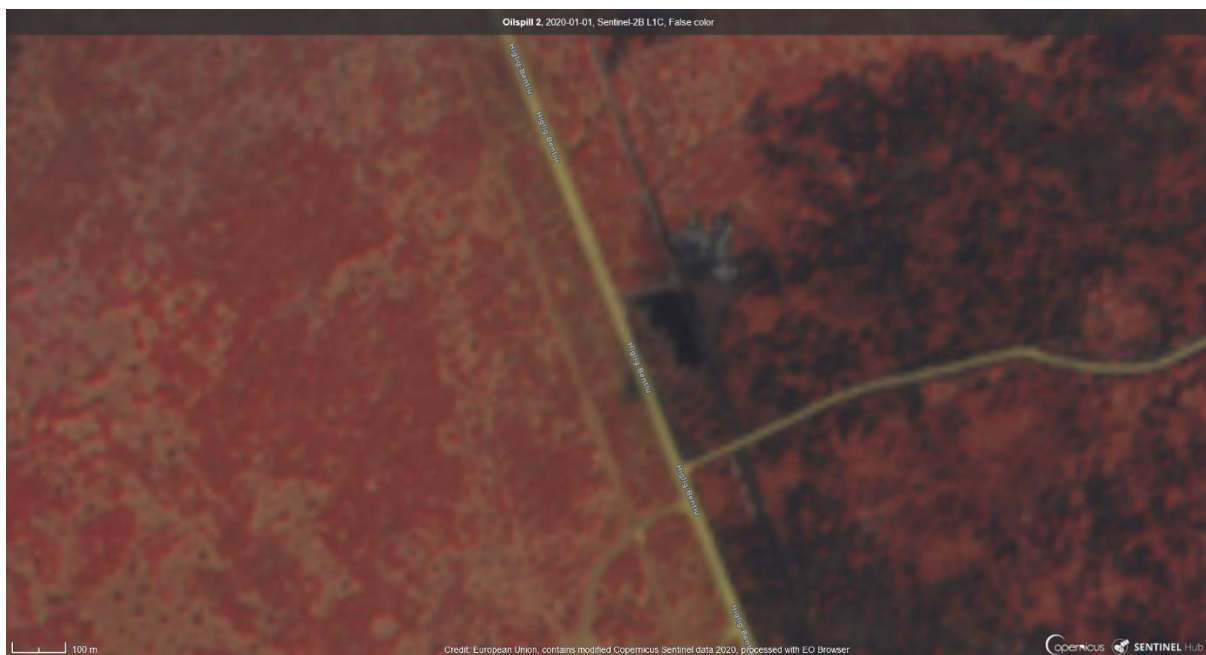
Figure 21: Image from January 1, 2020. Massive spreading towards the southwest is being joined by an already visible expansion towards the northeast.

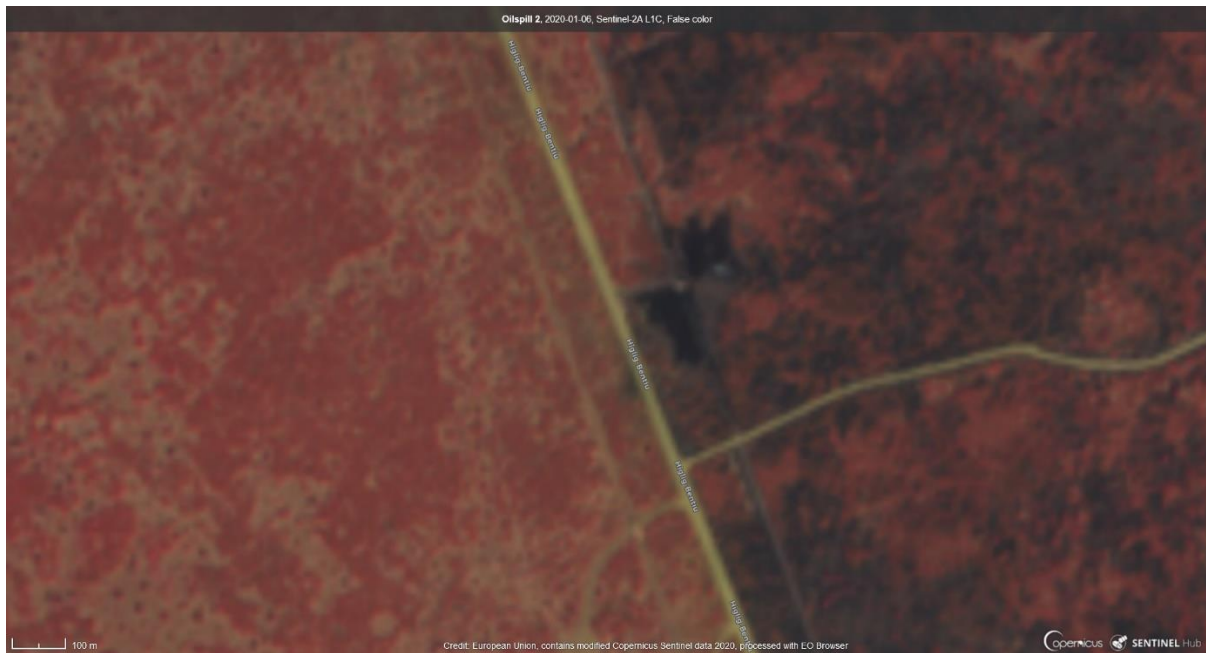
Figure 22: Image from January 6, 2020. Massive spreading towards northeast.

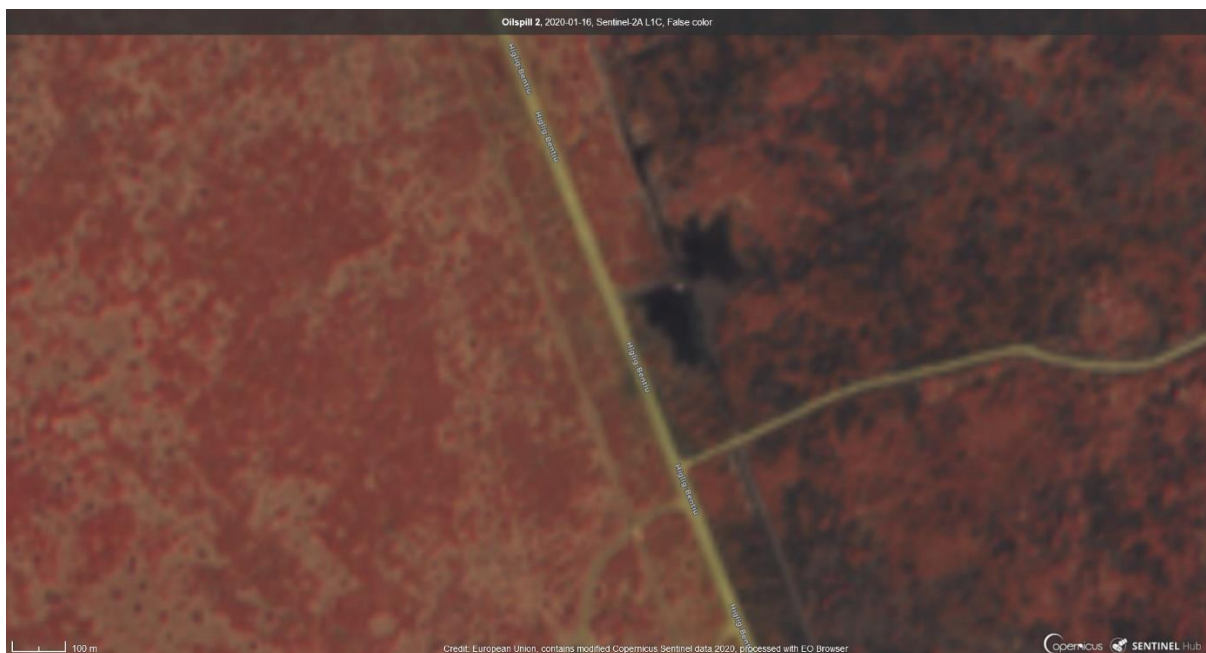
Figure 23: Image from January 16, 2020. Additional black spot spreading along the surface of the pipeline's path toward the north. Image shows the greatest expansion of the area of contamination. A basic measurement reveals the expanse to be around 20,000 m². The assumption of a layer thickness of oil of a mere 20 cms over the entire surface of contamination yielded a calculated oil spill amounting to some 25,000 barrels or some 4 million liters of oil.

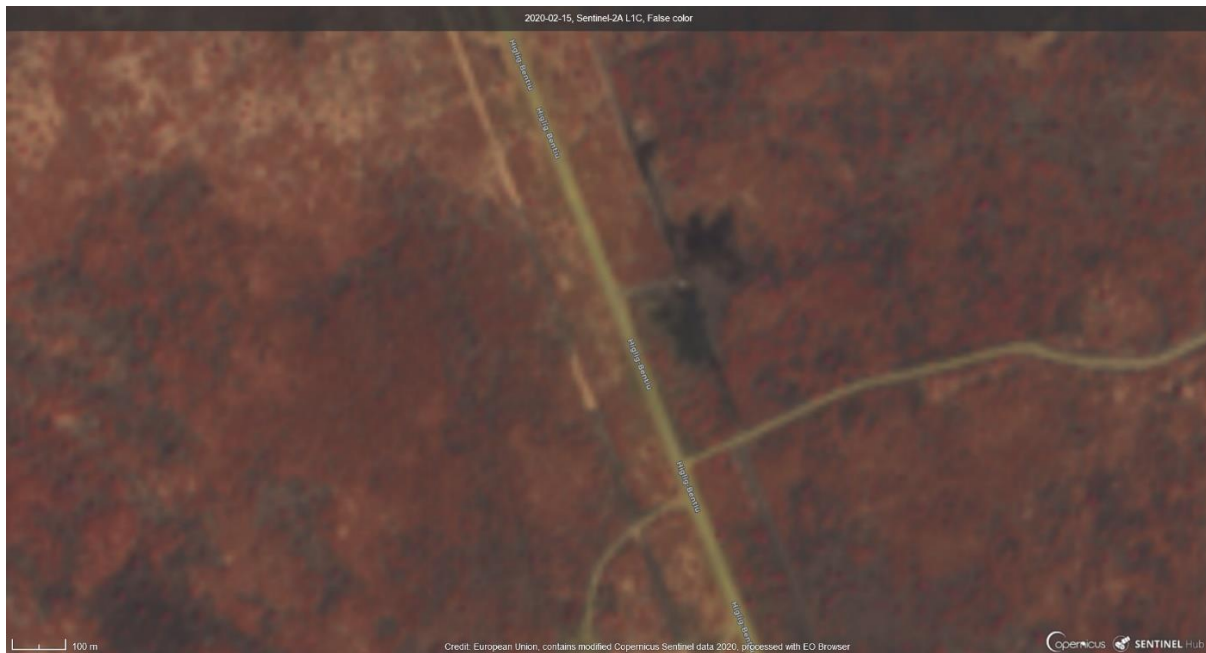
Figure 24: Image from February 15, 2020. Recognizable is a reduction of the area of contamination. Two possible reasons can be identified: repair and remedial measures included the removal of oil – or the spreading of soil over the oil-saturated surface.

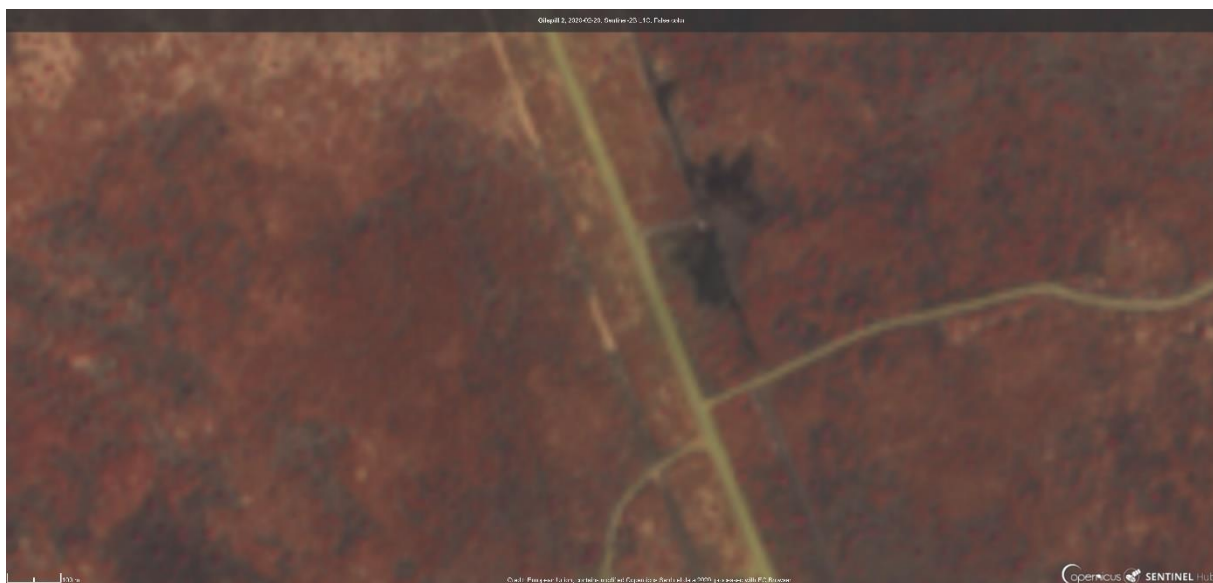
Figure 25: Image from February 20, 2020. Situation remains essentially unchanged from February 15, 2020.

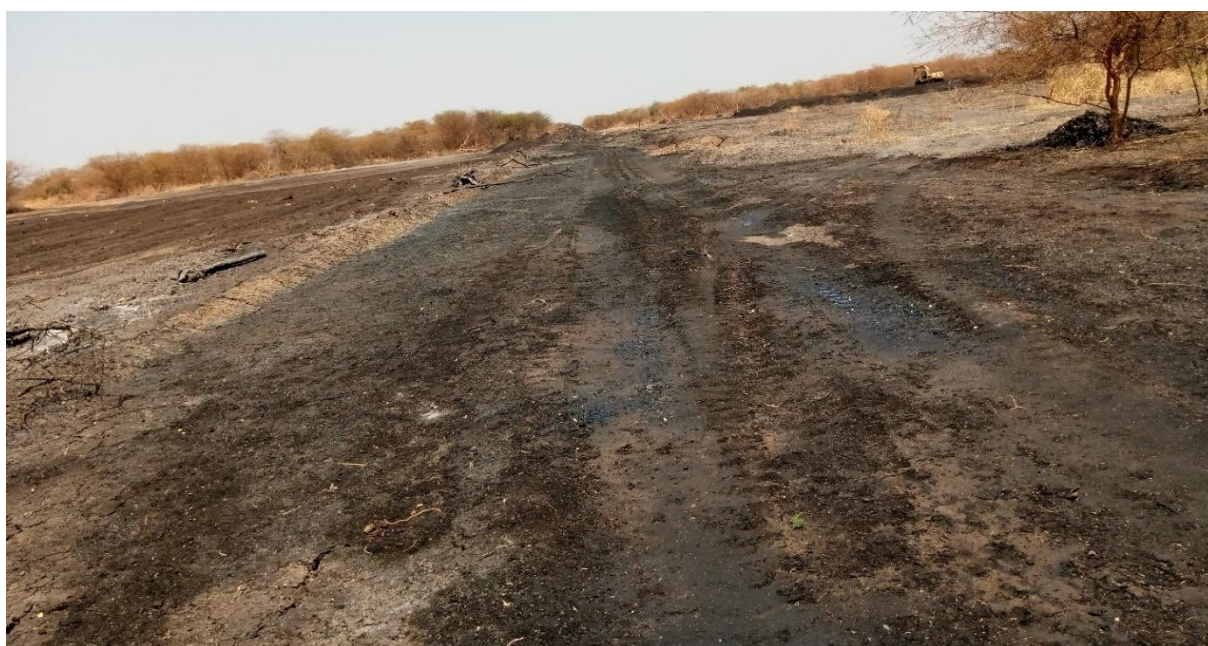
Figure 27: A first overview of part of the expanse of oil spill 2. It shows that a large part of it was excavated, and that the remaining surface was worked upon by heavy equipment. Much of the soil was obviously stripped from the ground and shoved together. This caused mounds of earth – much of comprised of black, oil-saturated soil – to be visible throughout the entire site. The images show the tracks of a bulldozer. Highly noticeable is that oil is seeping through the tracks' imprint. This means either that (1) dry soil was deposited upon

the oil-contaminated area – or (2) the removal of earth from the surface didn't go deep enough to collect all of the oil – obviously of a great amount - lurking below the surface. This oil keeps on seeping through to the surface, or rising to such upon the exerting of pressure.

The repairing of the rupture in the pipeline – should it have taken place – still leaves a large expanse of oil-contaminated surface and materials to be cleansed, remediated and disposed of. A proper cleaning-up of the area affected has not been done until the date of the on-site-investigation.

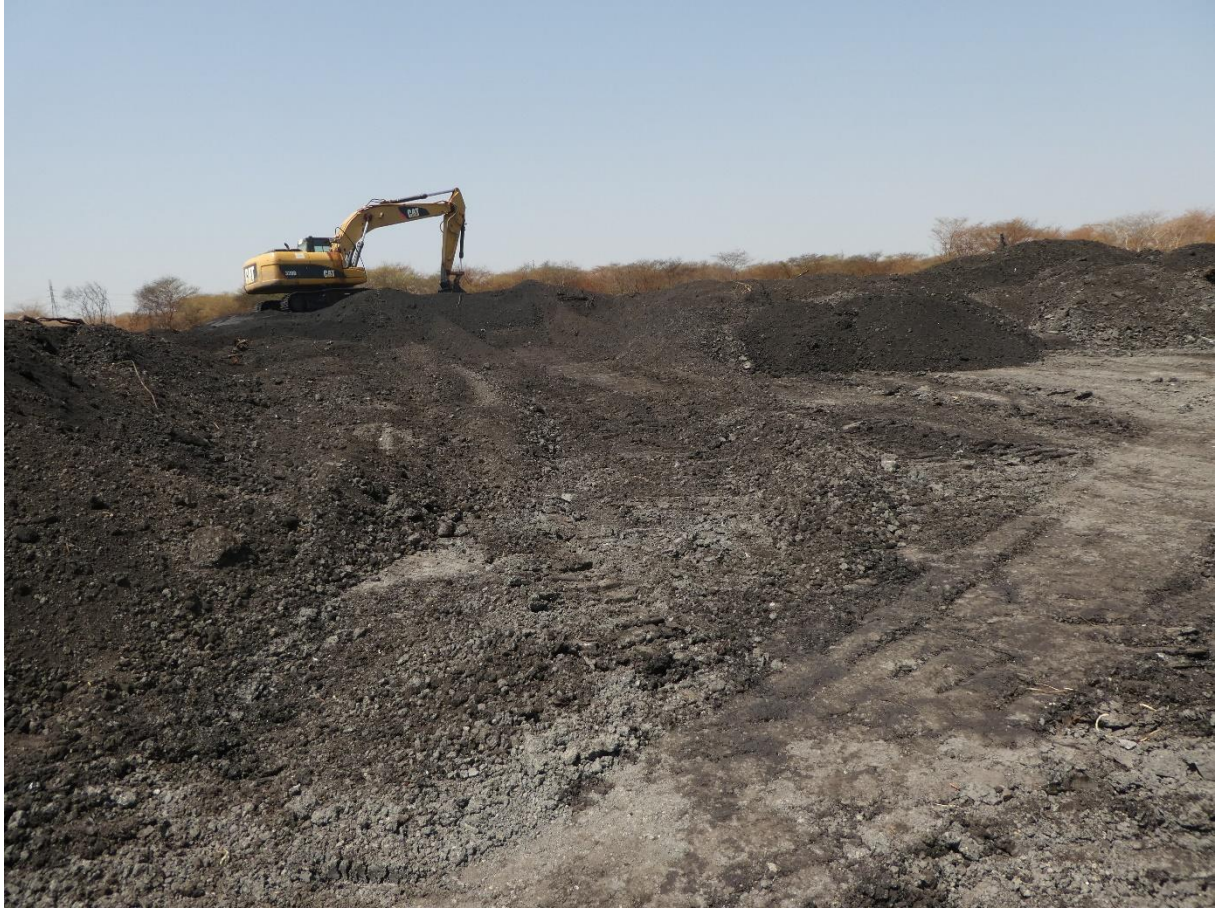
Figure 28: As of the time of the on-site investigation, heavy equipment was still to be found on the site of oil spill 2. Bulldozers were used to remove a layer of the soil and to shove it into mounds. Noticeable are the various colors of the soil in the mounts. The black piles are presumably comprised of oil-saturated earth.

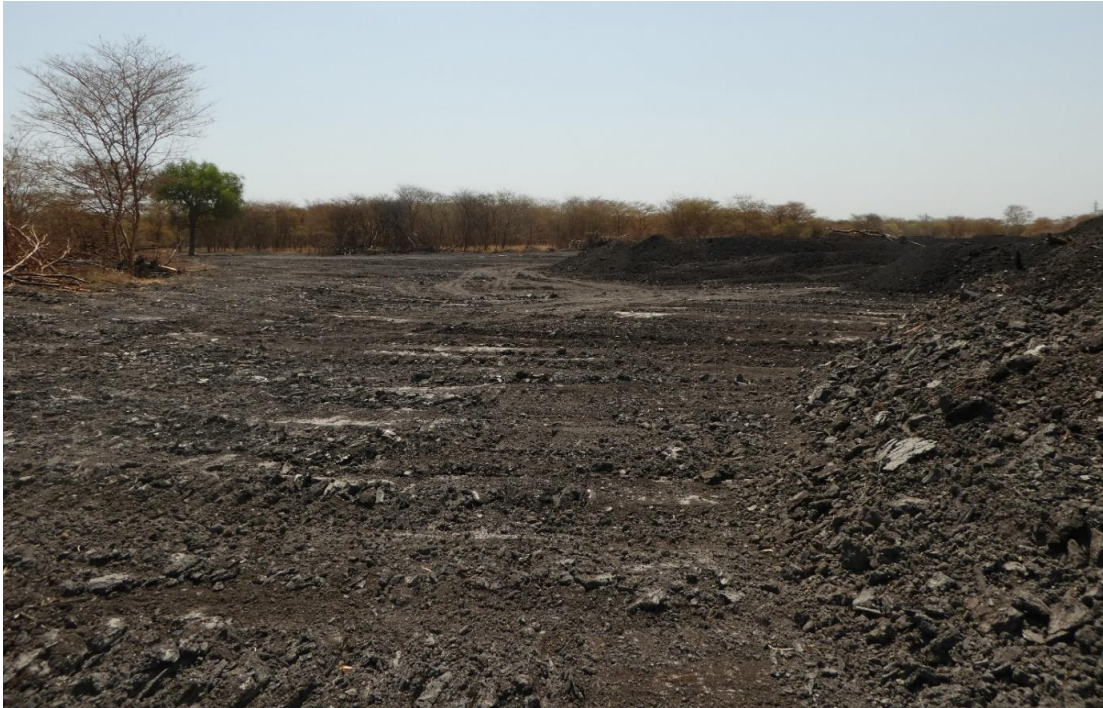
Figure 29: A further photograph that shows the large scale excavation of the uppermost layer of soil.

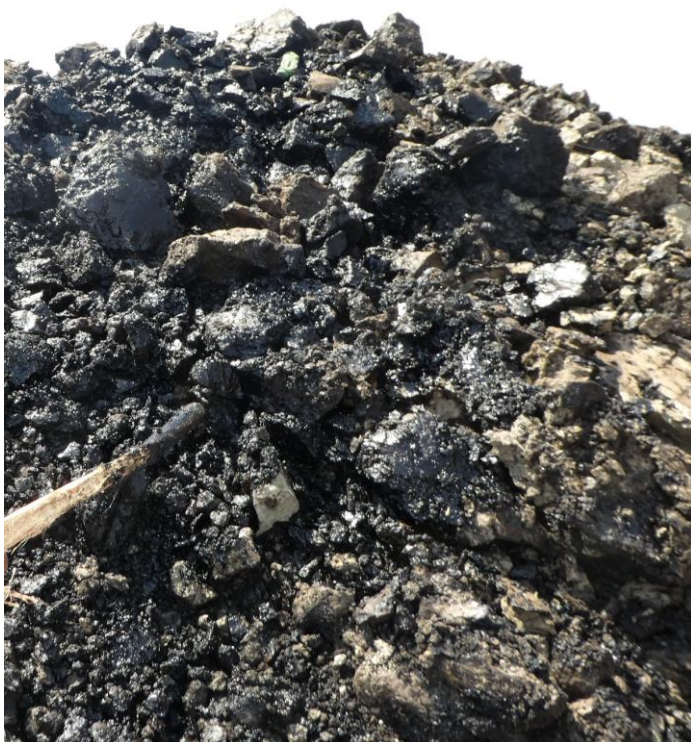
Figure 30: This close-up is clearly of oil-saturated clumps of earth.

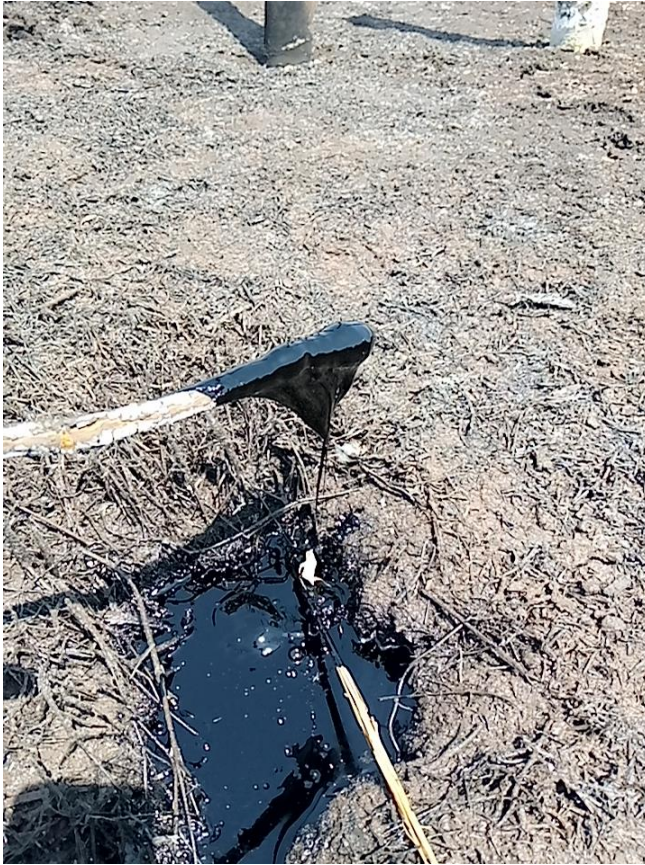
Figure 31: This photograph shows a crack in the surface with an expanse of some 30 cm x 40 cm. This has enabled the emergence of a puddle of oil. Its surface is some 10 cms below the edge of the surface. This photograph gives rise to the conclusion that the oil in this area at least was not removed and disposed of, but, rather, simply covered with earth. A “rod test” shows that the liquid’s viscosity is that of oil.

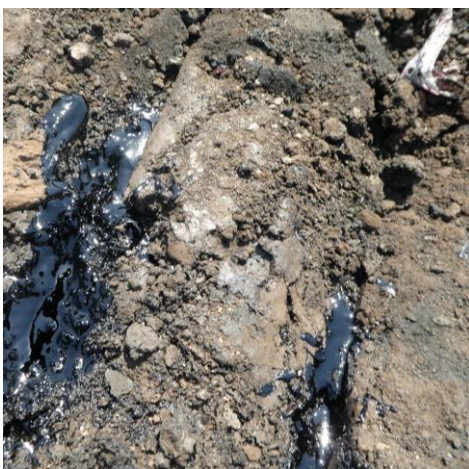
Figure 32: This close-up also shows oil that has risen to the surface, upon which it is dispersing.

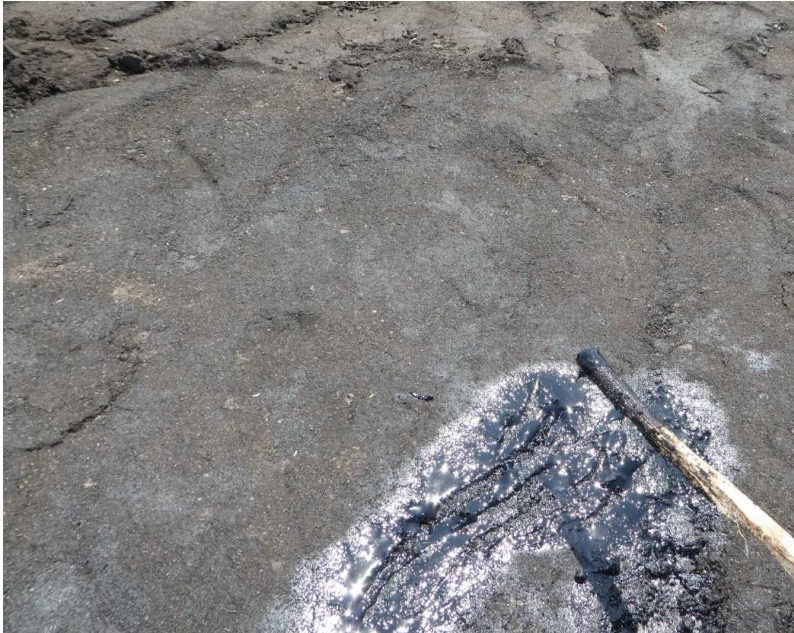
Figure 33: This close-up of the ground shows that oil has risen to the surface. The use of a “rod test” reveals that the liquid’s viscosity is that of oil.

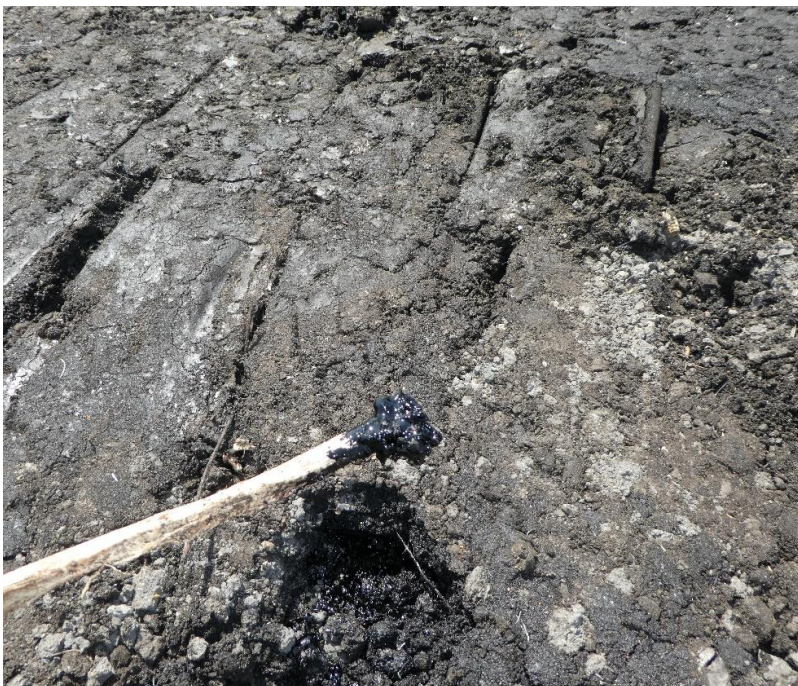
Figure 34: Breaking through the top of the ground with a rod shows that oil and oil saturated earth is to be found some 5 cms below the surface.

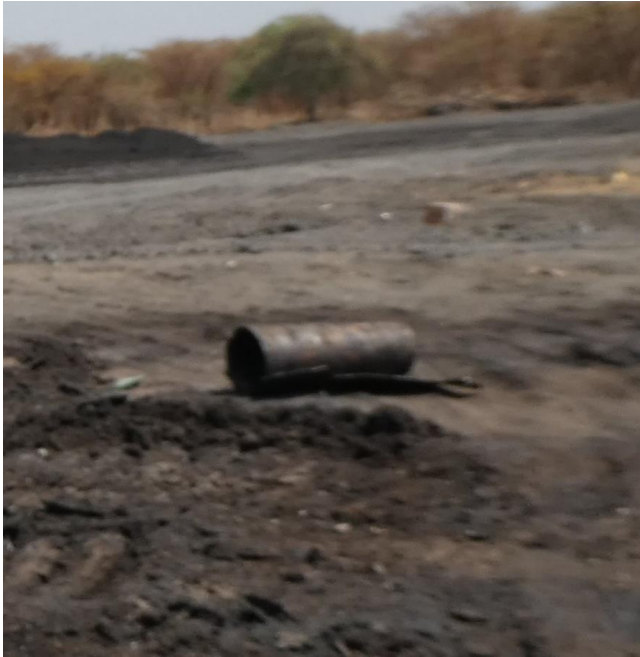
Figure 35: A piece of what is probably a metal pipe was found on the site of oil spill 2. This could have been left by those carrying out repairs of the pipeline.
