Causing a Black Tide of Oil – South Sudan's Polluting Pipeline

Konstanz, Germany, February 25, 2020,
Hoffnungszeichen | Sign of Hope e.V.

Key findings

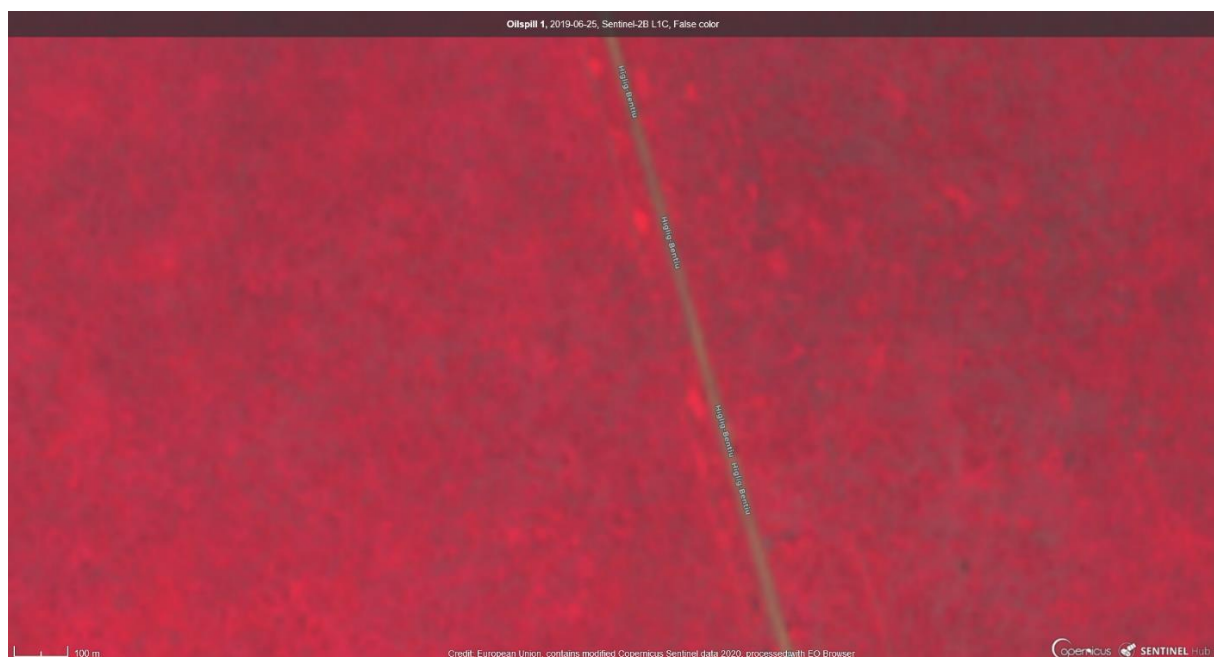
Figure 5: Image from June 25, 2019. It shows what the area around the intact pipeline looks like. This serves a benchmark for future events.

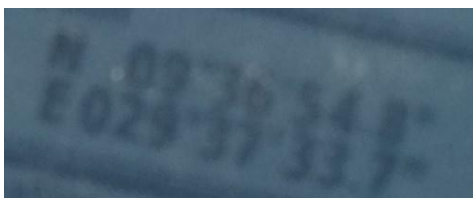
Figure 12: Comprised in the on-site investigation was the incorporation of the GPS data: N 9°36'54.8\";

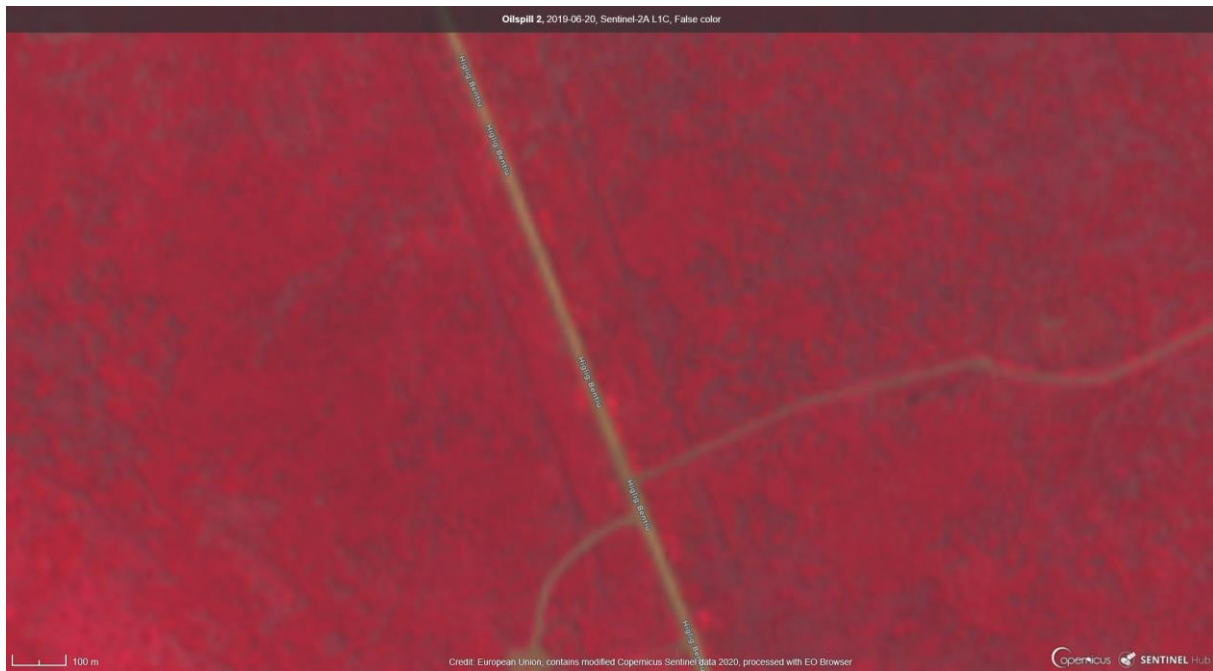
Figure 18: Image from June 20, 2019. It shows the undamaged pipeline, and thus serves as a point of reference.

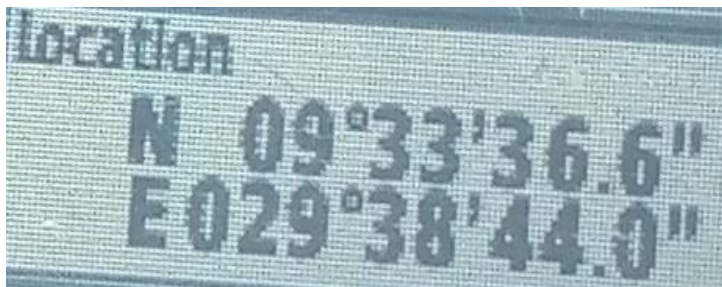
Figure 26: The on-site investigation comprised the incorporation of the GPS data: N 9°33'36.6"; E 29°38'44.0" – proof that the on-site investigation was taking place precisely at oil spill 2, the area indicated by satellites-generated images.
